No. : XMIN2412003346ML02_EN Date : 2025-01-03

Sample Name : Middle Clamp

1. Pull test

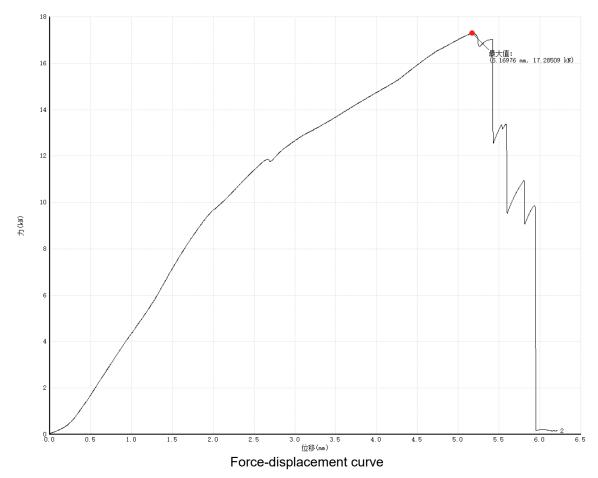
Test curve:

Test Item	Maximum force(kN)	The displacement at maximum force(mm)
Result	17.29	5.17

Test method: According to the client's requirements, fix the sample on the test machine. Apply the pull force as a rate of 5mm/min till destruction. Determine the maximum force. Test schematic:
